# **Gulf Gate Area Study**

Transportation Planning  
1001 Sarasota Center Boulevard  
Sarasota, FL 34240

June 16, 2020

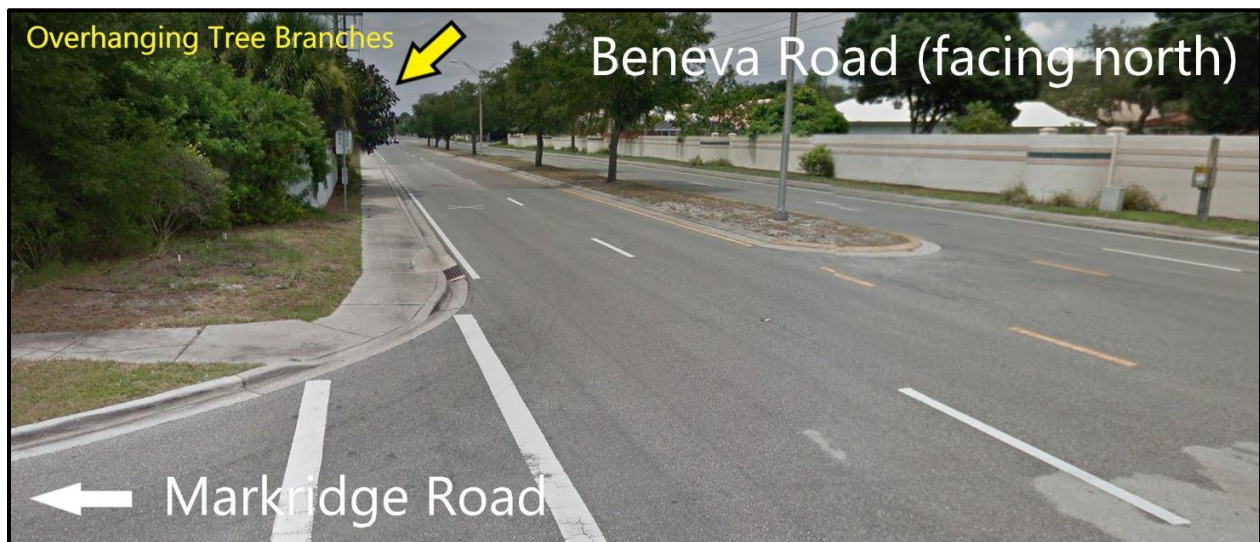
Figure 11 – Overhanging Tree Branches

Two of the reported crashes at the intersection of Markridge Road and Beneva Road were because the motorists did not properly judge the oncoming speed of the southbound vehicles on Beneva Road and drove into traffic from Markridge Road. A possible factor in these crashes is that the driver's vision was obstructed by overhanging tree branches as shown in **Figure 11**. These branches are from a rubber tree growing on private property. Due to the tree's growth habit, the branches will need to be trimmed approximately every 3 to 6 months in order to keep from obstructing the view for motorists coming out of Markridge Road. Another solution would be to remove the rubber tree and replace it with a tree that will not create a continuous sight distance problem.

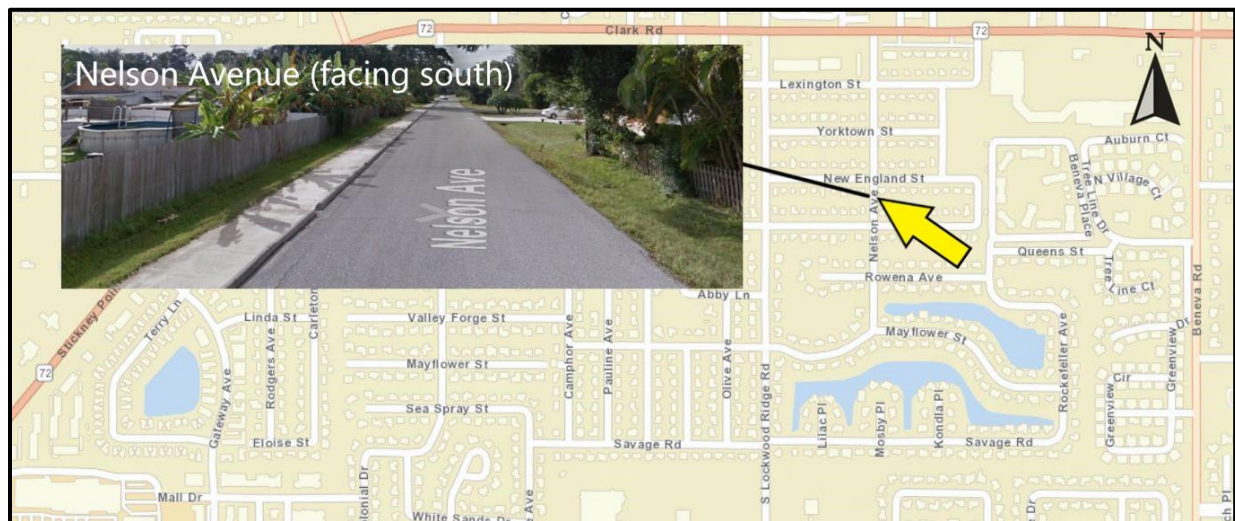
Figure 12 – Location of Bicycle Crash

There was a crash on Nelson Avenue at 6:57 PM on March 11, 2017, that involved a bicycle and a motor vehicle. The location of the bicycle crash is identified in **Figure 12**. The Florida Highway Patrol reported that a bicyclist was riding southbound on Nelson Avenue while a motorist was also travelling southbound on Nelson Avenue. The motorist had an estimated speed of 30 mph. At 100 feet south of the intersection of Nelson Avenue and New England Street the bicyclist cut across the roadway directly in the path of the motor vehicle. The motor vehicle collided with the left side and rear tire of the bicycle. There were approximately 10 feet of skid marks from the motor vehicle leading to the area of the collision. The patrol officer charged the bicyclist with failure to yield to traffic.

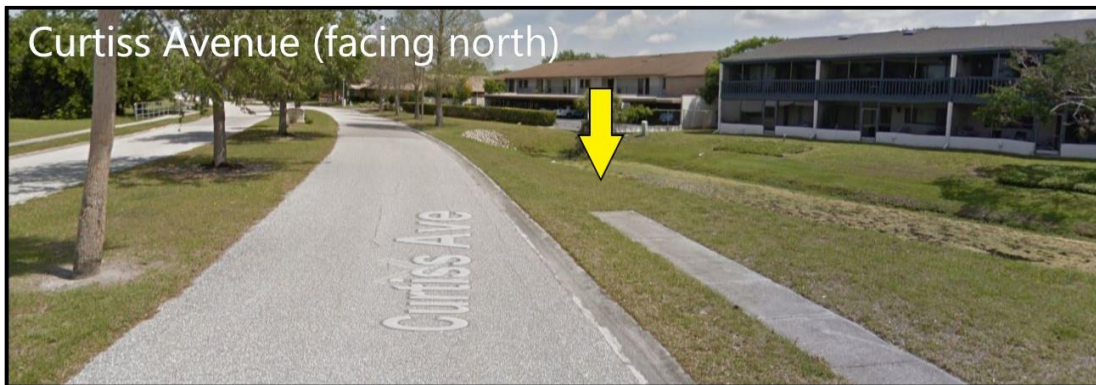
Figure 13 – Sidewalk Termination on Curtiss Avenue

It was reported that the sidewalk along the east side of Curtiss Avenue terminated at 270 feet south of Cloister Drive. **Figure 13** illustrates the condition of the sidewalk at this location. Sarasota County acknowledged this issue and initiated work to install signage to indicate the termination of the sidewalk. The installed signage is shown in **Figure 14**.

The sidewalk gap on the east side of Curtiss Avenue extends from the sidewalk termination northward to Gulf Gate Drive and runs approximately 1,400 linear feet. The gap is not currently identified in the Sarasota County Sidewalk Priority Program. A sidewalk request form must be completed and submitted to Transportation Engineering in order to be added to the list of

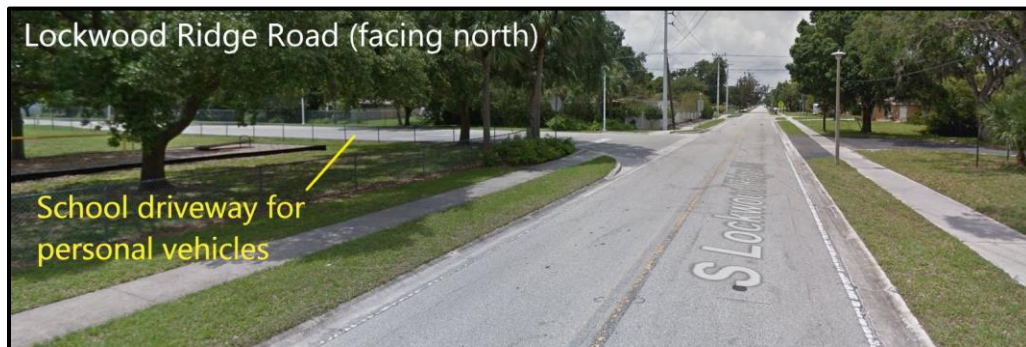
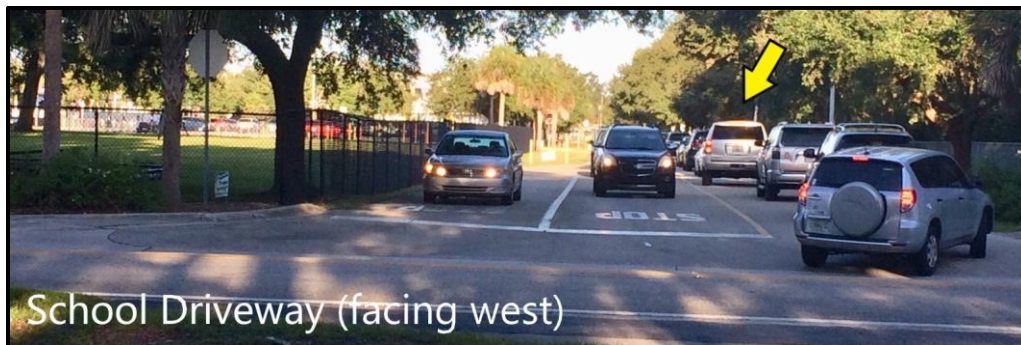
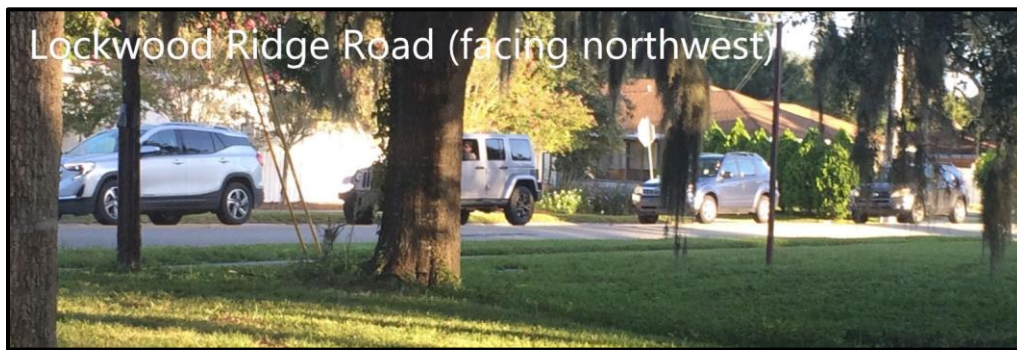
It was reported that queueing of personal vehicles from parents dropping off and picking up their children at Gulf Gate Elementary School causes traffic backup onto Lockwood Ridge Road (**Figures 15, 16 and 17**). The principal of Gulf Gate Elementary School stated that there are vehicles queued on Lockwood Ridge Road in the morning and afternoon due to approximately 500 vehicles entering the school at these times. She stated that her staff assists with the ingress and egress of these vehicles which takes about 30 minutes in the morning and afternoon to process. She further stated that queueing of vehicles onto the roadway network occurs at other schools in the county such as Riverview High School. The principal stated that she has addressed this issue, but no solution has been found to the temporary stacking of vehicles onto the roadway network. Parents are also using the parking lot at Gulf Gate Church located on the other side of Lockwood Ridge Road as a drop-off/pick-up area for their children.

It is recommended that the layout of Gulf Gate Elementary School be evaluated to determine if vehicles can queue on site rather than on Lockwood Ridge Road. Assessments have been successful at other school locations such as Ashton, Tatum Ridge, Philippi Shores and Fruitville Elementary Schools to add onsite queuing and lessen the queuing on the roadway.

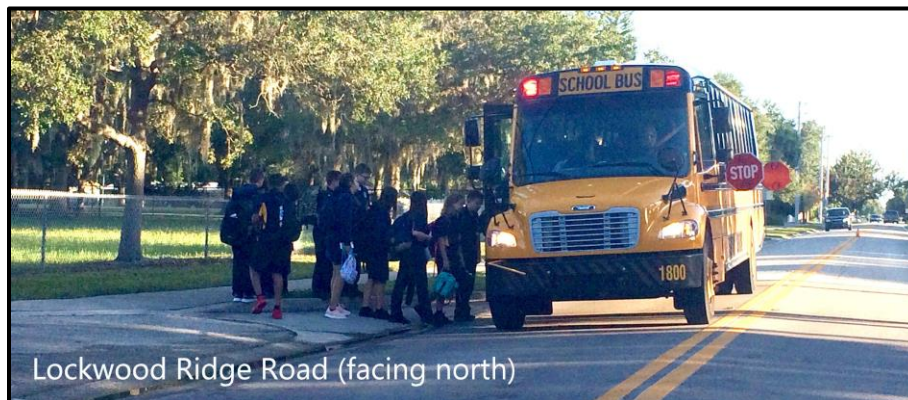
Figure 18 – School Bus using Gulf Gate Elementary School as a Hub

Gulf Gate residents reported that other schools such as Sarasota Military Academy Prep and Riverview High School are using Gulf Gate Elementary School as a drop-off and pick-up hub that generates additional trips through the community (**Figure 18**). Speeding was reported on Markridge Road caused by parents in a hurry to drop-off and pick-up their children at the bus stop on Lockwood Ridge Road.

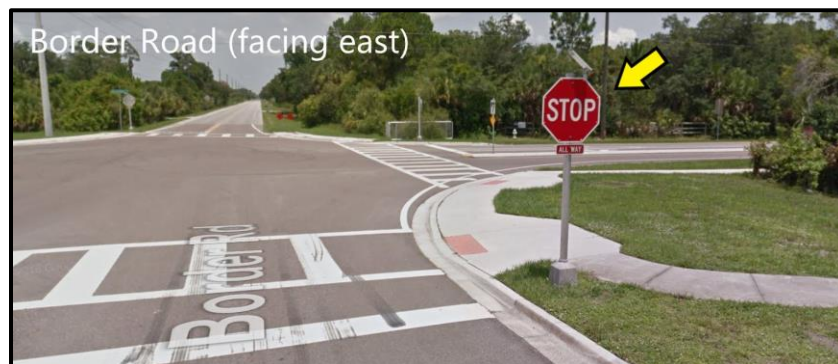
Figure 20 – LED Stop Sign

LED Stop signs are typically used when there is limited visibility on the approach to an intersection or at a junction that does not have a stop controlled intersection for several miles. In these circumstances the LED Stop signs are intended to enhance visibility of the sign and increase stopping compliance by capturing the driver's attention. The LED Stop signs alert motorists of upcoming roadway changes so they do not unintentionally run the stop sign (**Figure 20**).

A representative of GGCA proposed using Flashing LED Stop signs at the Gulf Gate Drive and Curtiss Avenue intersection. The expectation is that the flashing LEDs would alert motorists to the stop signs and improve stopping compliance at the Multi-Way stop intersection. Multi-Way Stop signs, however, have been established at this intersection for several years. It is not

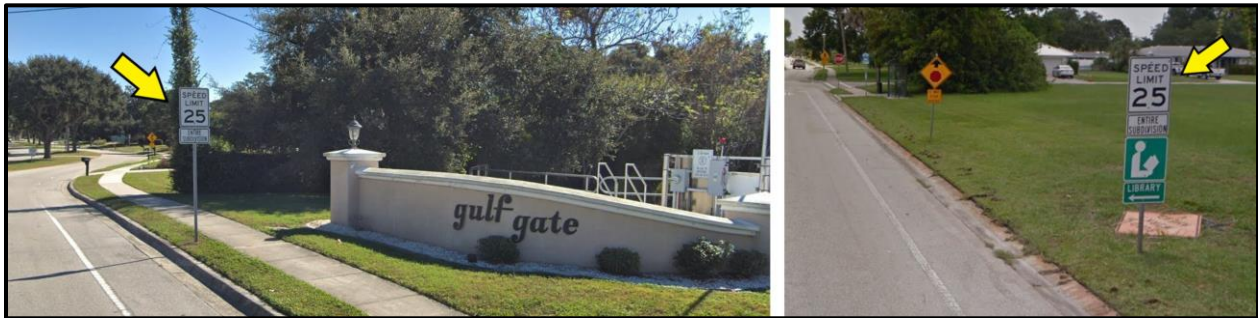
The Manual on Uniform Traffic Control Devices (MUTCD) contains standards, guidance and options for signing within the right-of-way of roadways open to public travel. The MUTCD states that speed limit signs shall be located at points of change from one speed limit to another. Speed limit signs have therefore been installed at the entrance locations to the Gulf Gate community where the speed limit changes from the arterial roads, collector roads and adjacent streets to the community local roads (**Figure 21**). Additionally, there are plaques below these signs to indicate that the speed is applicable to the entire subdivision (**Figure 22**).

A guidance within the MUTCD is that regulatory signs such as speed limit signs should be used conservatively because these signs, if used in excess, tend to lose their effectiveness. Therefore, county staff does not recommend installing additional speed limit signs within the Gulf Gate subdivision in order to avoid excessive use and to maintain the value of the existing speed limit signs. The MUTCD also gives guidance that a Reduced Speed Limit Ahead sign should be used to inform road users of a reduced speed zone where the speed limit is being reduced by more than 10 mph or where engineering judgment indicates the need for advance notice to comply with the posted speed limit ahead. No locations have been identified within the Gulf Gate subdivision that require a Reduced Speed Limit Ahead sign.

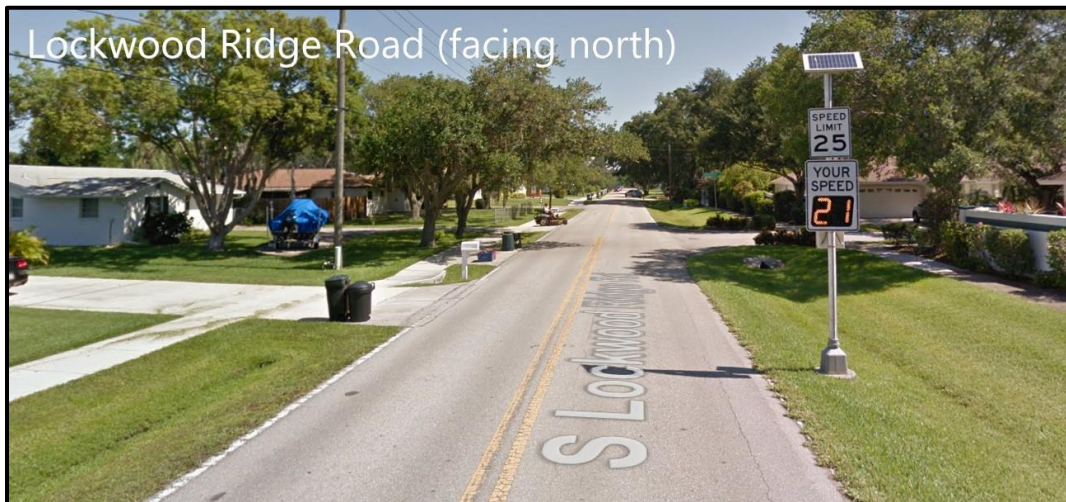
- 1) **Radar Speed Signs** are effective at slowing down speeding motorists and gives them the opportunity to change driver behavior. Radar speed signs have been installed north of the study area on Lockwood Ridge Road between Clark Road and Ashton Road. Similar signs could be considered for Curtiss Avenue and/or Markridge Road. It should be noted that these signs may lose their effectiveness after a few months due to motorists becoming familiar with the sign then complacent with their speed because the sign is not enforced.
